ACTIVITY COMPLETION REPORTING FORMAT

PROJECT NAME: Lifesaving and Livelihoods Restoration Project-III (LLRP-III)

ACTIVITY: Rehabilitation of water pan

ACTIVITY LOCATION/ VENUE: Owru-dimtu village, Elwak district; Gedo region

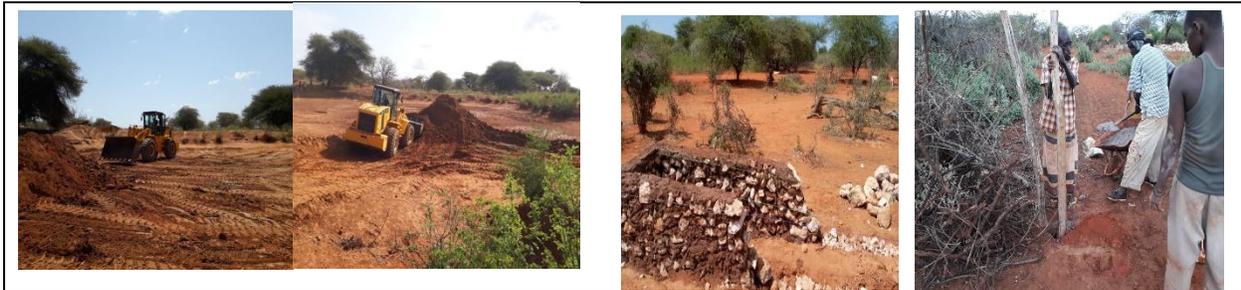
SCZ: Gedo region;
Situation of Owru
dimtu water pan
before
rehabilitation in
Owru-dimtu
village, Elwak
district.

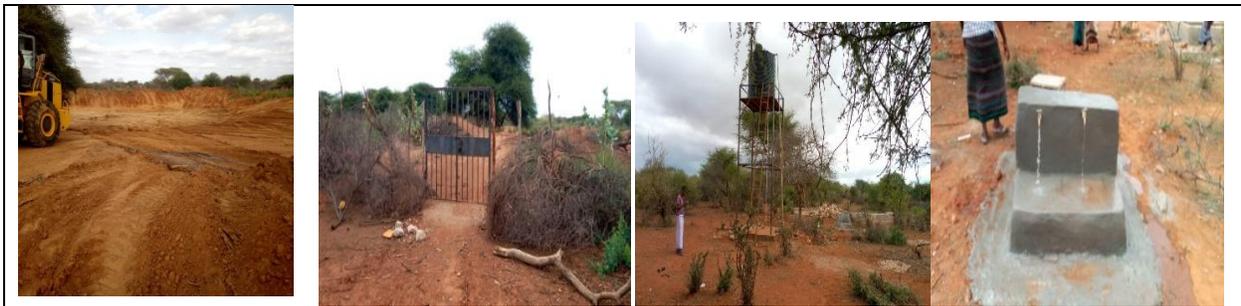
SCZ: Gedo region; bulldozer the pan, trough and installation of gate during rehabilitation of Owru dimtu water pan in Owru-dimtu village, Elwak district.

Bulldozer was used as method of excavation tools for land grading and leveling of the soil earth, desilting and protecting the nature of water pan to increase the water holding capacity during rainy season, which will to effectively sustain livestock herds and humans who depend on the pans as the only source of water available. installation of sand filtration unit was done between the water pan and elevated tank.
